# Restoration of a ROTOTILLER MODEL 2

By Charlie Zuck |

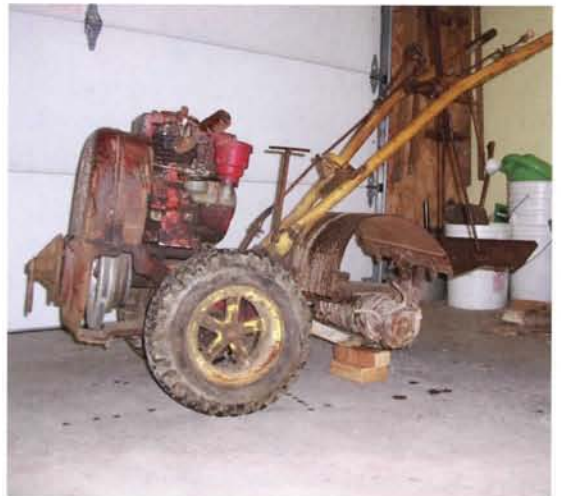
The photo to the right is what this 1957 Model 2 looked like when I purchased it.

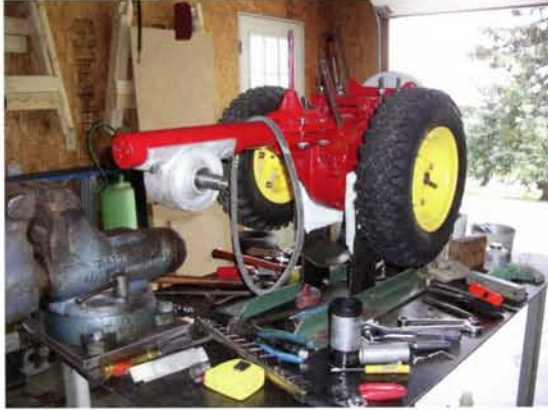
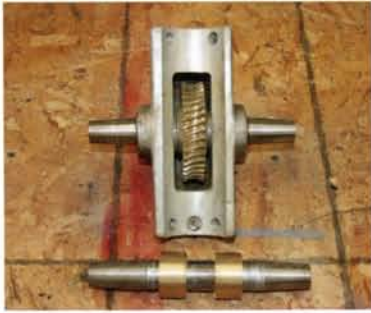
The first area you want to inspect is the tiller rear gearbox and enclosed worm gear. This gear and rear bearing takes all the abuse and wear. Other

than getting one from another machine, I don't have a source for a new one. The brass worm gear is very easy to access by removing the four bolts that attach the aluminum gearbox to the main tube.

Pictured is the gear case with new shaft and brass bushings already installed. Normally the shaft needs replaced if the bushings are worn. Some of these tillers will have a 1/4-inch tiller shaft and those will have ball bearings, instead of the brass bushings used on the 1-inch tiller shaft. The 1/4-inch shaft is the same shaft used in the Troy-Bilt Horse for many years. I had a machinist friend make a shaft for me for this restoration. Since then, there is a fellow making the 1-inch shaft and bushings, and he provides two seals. His information is on my website under "Parts Resource List."

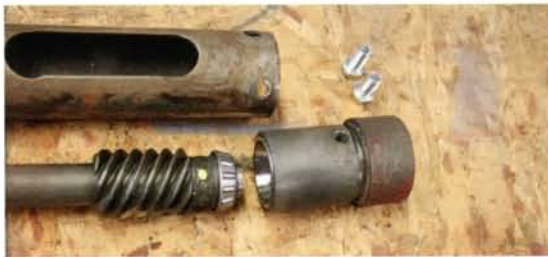
The rear bearing and the spacer next to it also wear. I have replaced the rear bearing with a new one or a good used one from the front position of a parts machine. When the shaft is assembled into the tube, there should be little to no noticeable endplay on the shaft. If there is excessive endplay, you will need shim washers between

the spacer (noted with the yellow dot) and worm. There also may be shim washers between the bearing and rear snap ring to limit endplay of the shaft.

This is a photo of the whole tube. The front or left bearing does not see much load. I have used this bearing from a parts machine to replace a worn rear bearing. The worm on the left is for the wheel drive worm gear, and I have never seen one of them worn out.

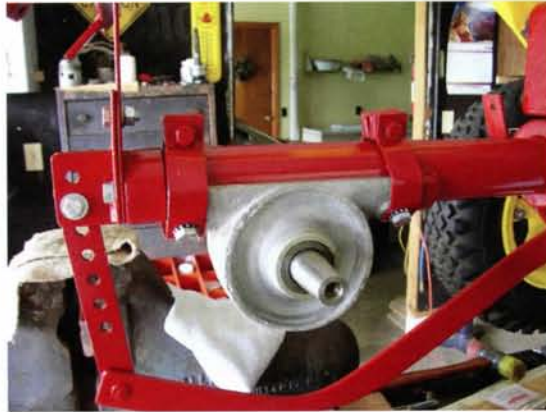
There is a paper gasket between the gear housing and tube. With no gasket, the worm gear mesh will be too tight. Normally 1/32-inch thick vellumoid paper gasket material will be the proper thickness to result in a good mesh. If the mesh seems too sloppy, try 1/64th-inch material. The best thing is to measure the old gasket thickness when you disassemble the tiller. There are plenty of places for leaks, so use a lot of sealer on the gasket and bolts. I use Permatex Aviation Liquid Sealant on the gasket and a small bead of black silicone around the underside of the bolt head when I assemble it for the last time. Below is a photo of the completed tiller section ready for tine holders.
